## Performance and Effects of SCS Floodwater Retarding Structures in the 1979 Easter Floods\*

Peter Forsythe

State Conservation Engineer

Soil Conservation Service

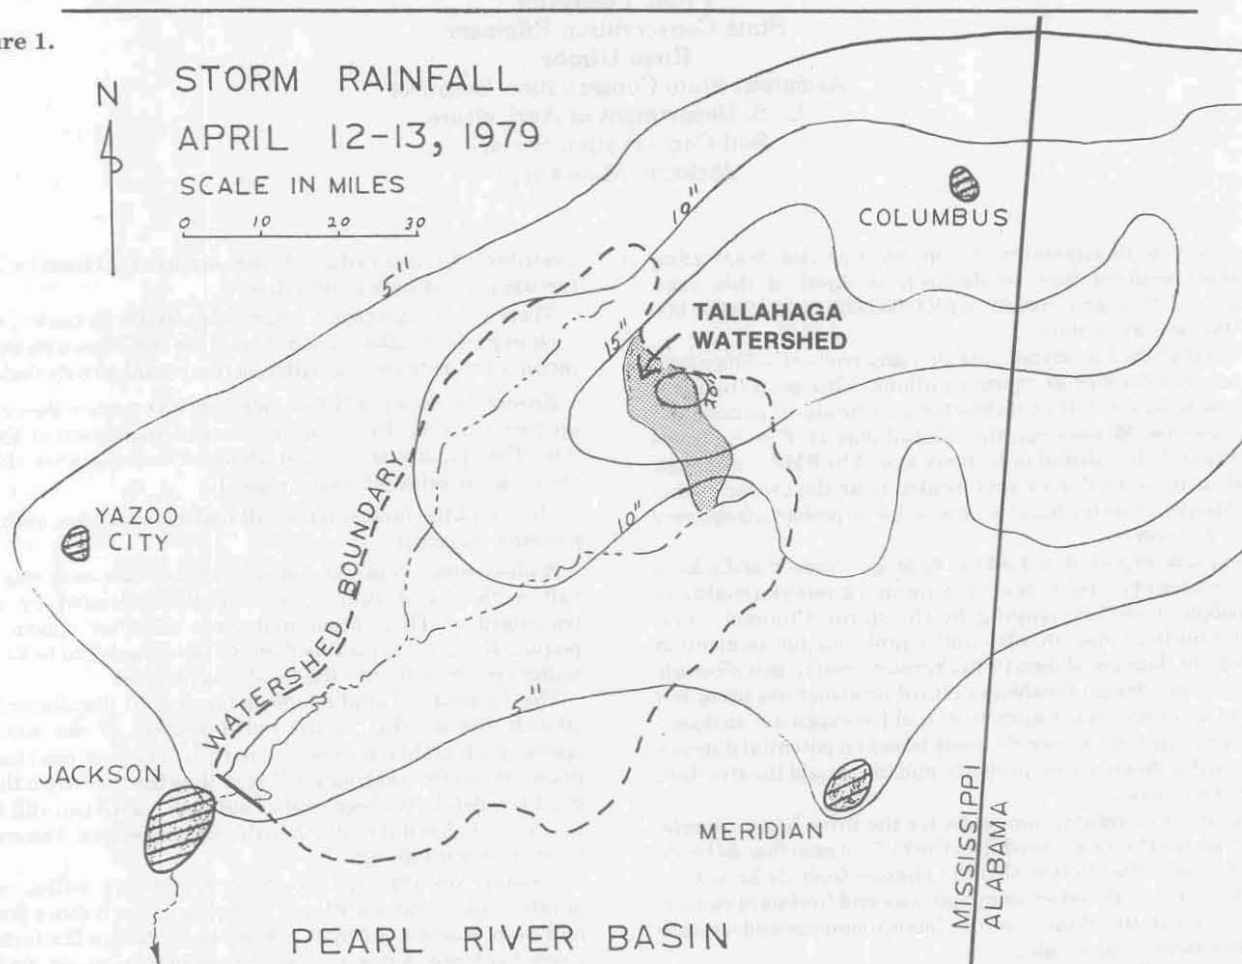
Figure 1.

The rainfall that produced this flooding covered a large area and was very intense at many locations. This map (figure 1) shows the total rainfall in inches for a 30 hr storm period.

At Louisville, Mississippi, the rainfall was 21.5" or 2.4 times the 100 year-24 hr rainfall or 69 percent of 6 hr PMP. Tallahaga Watershed in shaded area was located near the center of this storm. Many people try but it is impossible to project a frequency for such a storm.
