EVALUATION OF STONE DIKE SYSTEMS  
AND THEIR LOCATIONS ON THE  
LOWER MISSISSIPPI

Wallace H. Walters Jr.

Potamology Section, River Stabilization Branch  
U. S. Army Corps of Engineers, Vicksburg District  
Vicksburg, Mississippi

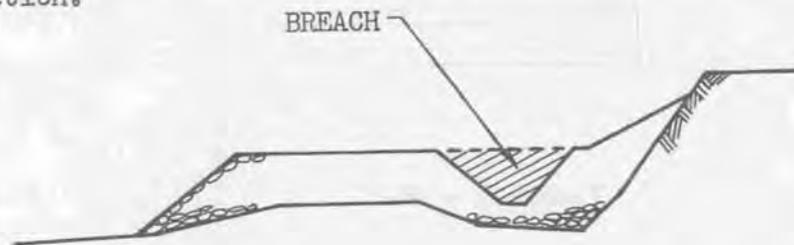
FIGURE 2 - PROFILE

1. Breach Failure. A dike is considered to be breached when the crown height has been reduced at a given location and usually assumes a V-notch shape. This type of failure has extended below the original bed profile in some cases and required more stone to repair than was in the initial section.

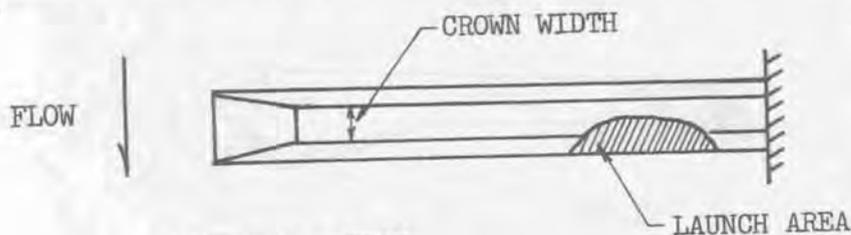
FIGURE 3 - PLAN

2. Launch Failure. Any loss of stone from either slope which may result in a decrease in crown width but not in crown height; however, if a sufficient amount of stone is launched the consequences may be a breach failure

In the majority of occurrences the downstream slope is involved and the failure may extend along almost the entire dike length. This is especially noticeable along guide vane slopes where strong lateral flow occurs.

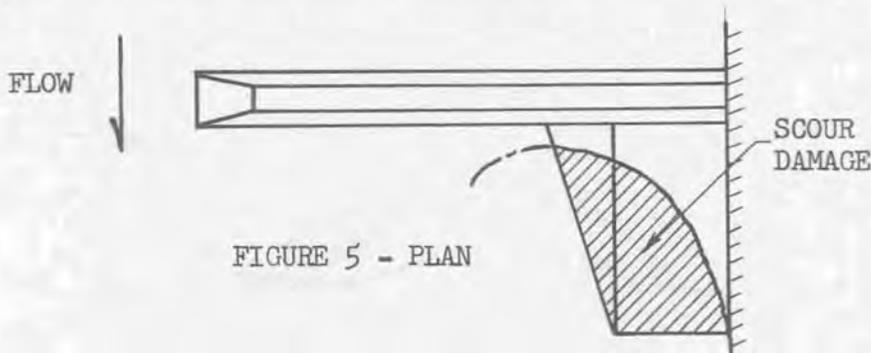
FIGURE 5 - PLAN

4. Bank Paving Failure. This is a semi-circular or crescent-shaped failure occurring in the paved bank downstream from the inshore terminal caused by eddy current action and may lead to a flank failure if left unrepaired.

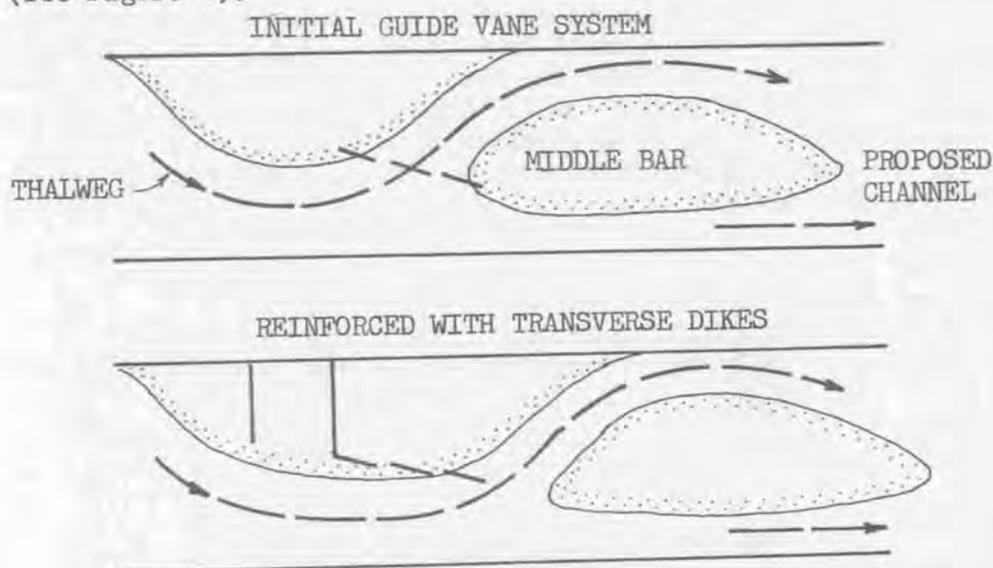
FIGURE 8 - BEN LOMOND VANE DIKES

In comparing the classified failures, it is apparent that the breach and launch-type are the most frequent and result in higher losses of stone. These types occurred predominantly at the crossing locations. The guide vanes at Ben Lomond and Leland Bar were placed diagonally in the crossing for the purpose of forcing the low water channel to follow one particular bankline contrary to natural river tendencies. These systems experienced excessive scour and stone loss. They also did not reduce the flow in the intended channel until assisted by other structures. It became necessary to reinforce the original guide vane system at Ben Lomond with transverse dikes upstream. Upon completion of the transverse structures a moderate amount of fill began to accumulate in the system. This had the effect of forcing the crossing downstream beyond the last guide vane, (see Figure 8).

As the vane system was extended downstream, similar scour patterns developed. Deep scour holes formed in the vicinity of the upstream and downstream terminals of the new vanes causing heavy stone losses and it was obvious that more transverse structures would be required for reinforcement.

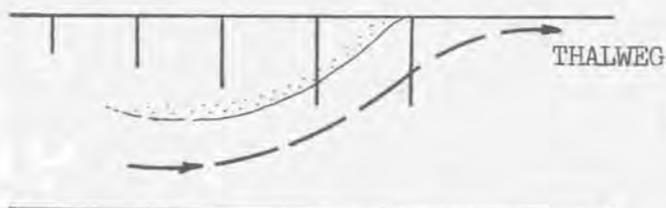
FIGURE 9 - BALESHED DIKE SYSTEM

The Baleshed system consists of five transverse dikes with the two downstream structures extending into a crossing. Stone dumping operations were extremely difficult due to high current velocities and construction was halted prior to completion with a recorded stone overrun of over 100 percent on dike no. 5.

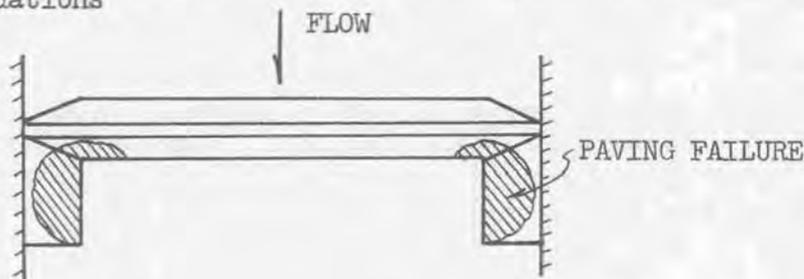
FIGURE 10 - TYPICAL FAILURE PATTERN

Dike systems constructed in secondary channels for the purpose of flow reduction usually extend from bank to bank similar to a rockfill dam or weir. In this situation there are two shoreline terminals per dike which are susceptible to damage. While this probably accounts for the high occurrence of paving failures in divided flow locations, (50 percent of the total), it also suggests that this is the main structural weakness of dikes in these situations

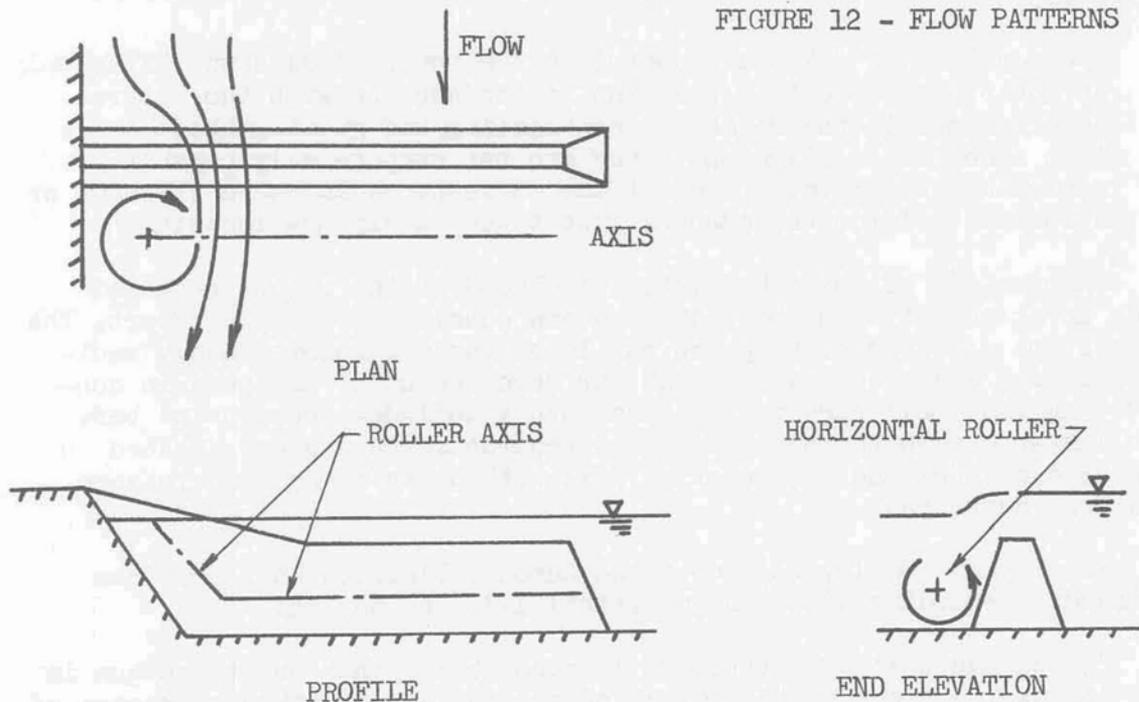
Where individual dikes tie into the bankline, a scour hole or pocket develops immediately downstream of the inshore terminal. The cause of these circular shaped scour holes is an eddy current which can be observed on the water surface at high stages. This eddy may be the result of the horizontal roller generated at the toe of the downstream slope where there is flow over the dike. As the roller approaches the shoreline, its horizontal axis may be tilted upward toward the surface following the bankline and upon reaching the surface, spreads out radially increasing its circular dimensions. Simultaneously, one must consider the surface flow around the inshore terminal crest which can cause an eddy circulating in the same direction. This is illustrated in Figure 12. It seems that the roller and surface eddy could easily amplify each other. Whatever the case may be, the eddies will remain in a particular area until the forces producing them are altered. A fall in stage to a level below that of the crown height should eliminate the causative forces and this seems to be the case judging from observations at low stages.

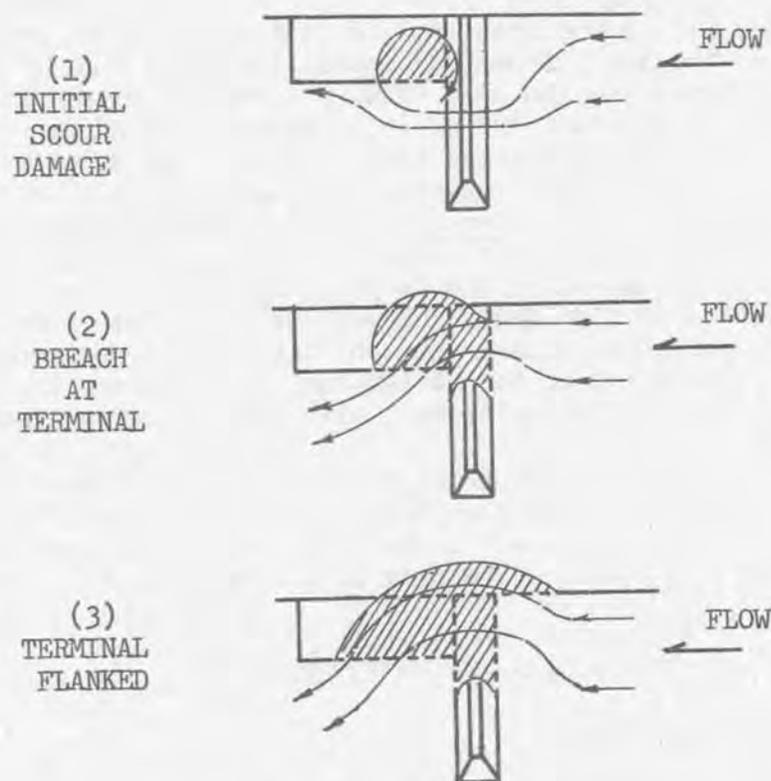
FIGURE 13 - FLANK FAILURE SEQUENCE

Flank failures normally begin with destruction of bank paving and some stone launching at the inshore terminal as a result of excessive scour. If a breach develops at the bankline, flow will concentrate through the gap and initiate bankline cutting. Since flanking usually requires the above sequence of events leading to a failure, this type does not readily occur as do the other types.

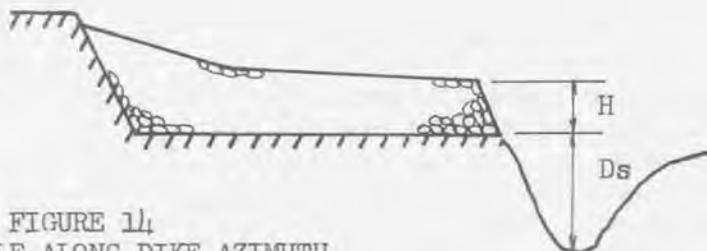
FIGURE 14  
SCOUR PROFILE ALONG DIKE AZIMUTH

It was desirable at this point to see if any relationship existed between the outshore terminal height ( $H$ ) and depth of scour ( $D_s$ ) at the terminal.
