## RESTORATION OF THE MISSISSIPPI STATE PORT AT GULFPORT

Jack V. Williams, P. E.  
Smith and Sanders, Inc., Consulting Engineers  
Jackson, Mississippi

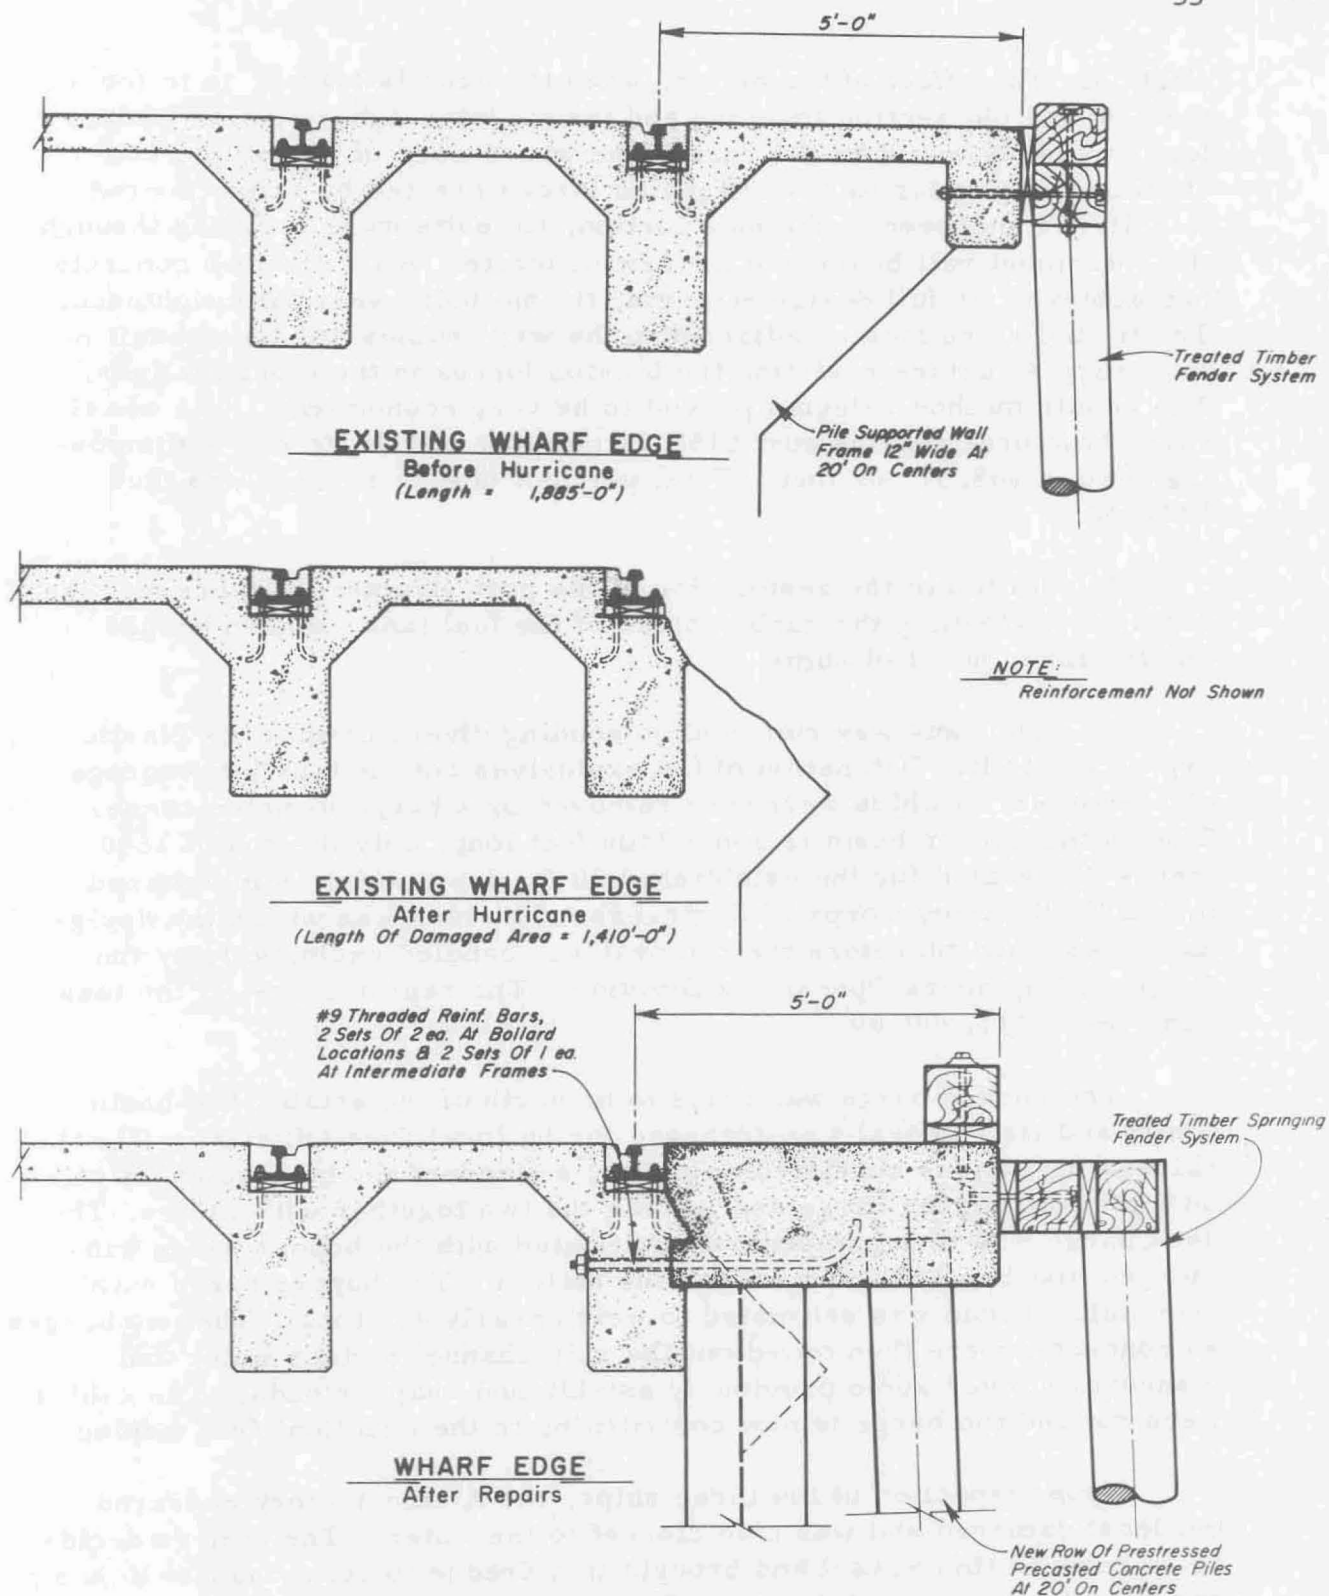
FIGURE 1

From the following sketch (Fig. 1) showing the details at the wharf edge, it can be seen that the outer row of prestressed piles are battered

slightly. The effect of the batter, when the deck is loaded, is to force the new and old section together and insure lateral distribution of the loads much as would be the case if the wharf were of monolithic construction. In order to resist tension forces created by ships moored to bollards anchored in the new portion, tie bolts were installed through the outermost rail beam into the new concrete. After the new concrete had achieved its full design strength, the tie bolts were fully tightened. The tie bolts are located adjacent to the wall frames and thus result in the entire structure resisting the tension forces in the mooring lines. The repair method selected proved to be very economical. The wharf edge structural repairs cost \$153.11 per foot and the fender and mooring system \$68.31 per foot. Total per foot cost of repairs was thus \$221.42.

Because it was considered impracticable to attempt to anchor a cantilever section to the remaining wharf which would satisfactorily resist vertical loads as well as lateral forces of moored ships, a procedure was conceived which required a single new row of piles along the outer wharf edge. Another change in reconstruction of the wharf edge was change from a timber fender system that depended primarily on crushing action of the timber members to absorb docking forces to a springing timber system which used bending action of the timbers to absorb the ships inertia.
