MODEL STUDIES OF STEELE BAYOU DRAINAGE STRUCTURE AND OUTLET CHANNEL AND REPAIRS TO OUTLET CHANNEL

Basil K. Arthur Hydraulic Engineer Corps of Engineers, Vicksburg District

PROCEEDINGS MISSISSIPPI WATER RESOURCES CONFERENCE 1985

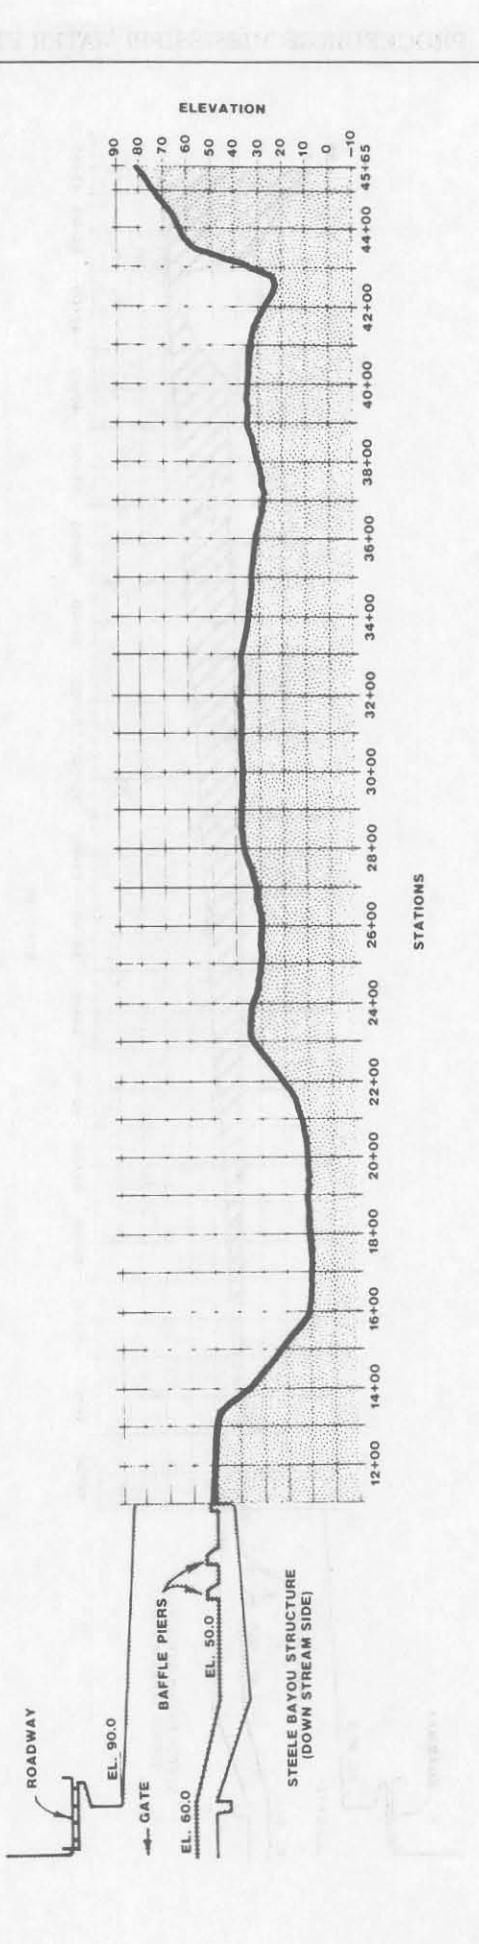
PLATE

The channel bottom deteriorated from approximately elevation 55 to elevation 35. This deterioration started below the riprap and continued to the Yazoo River with a large energy hole downstream of the existing riprap. (See Plate 4)

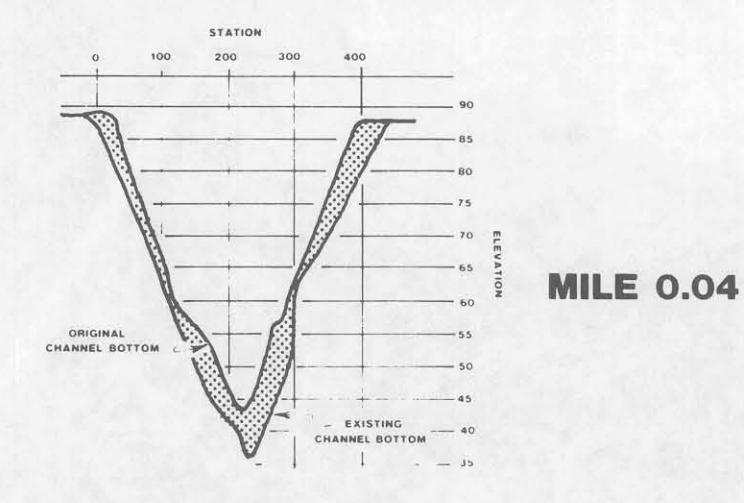
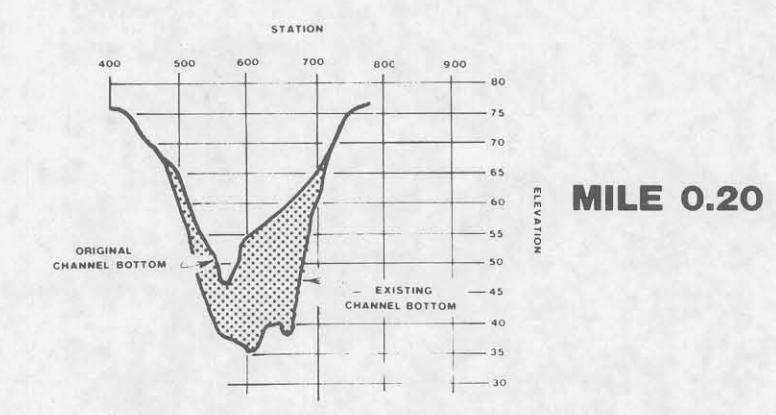
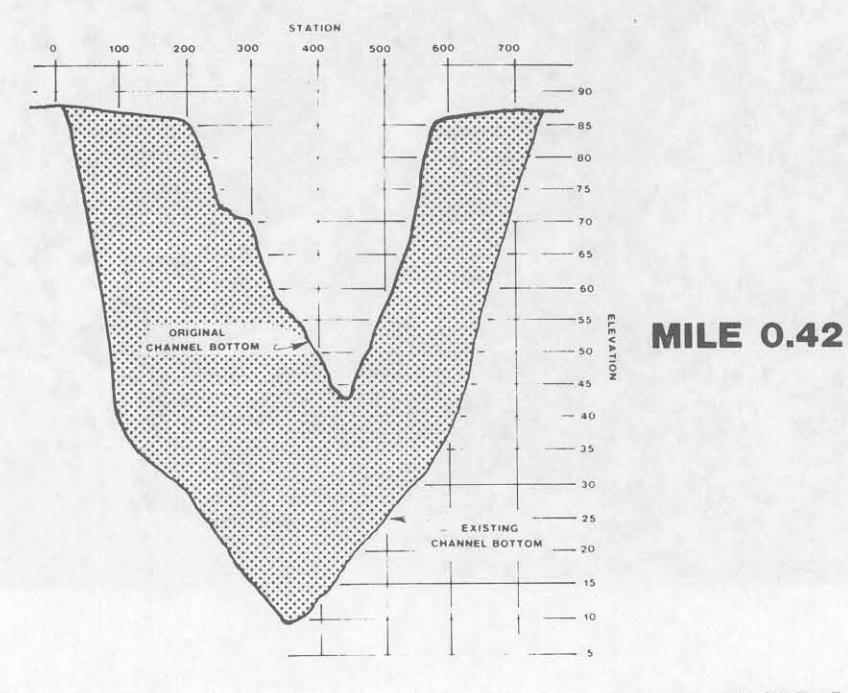
PLATE 5

The outlet channel continued to deteriorate and scallop until large scale eddies, standing waves, and vortices breached the access road during the spring runout of 1983. (See Plates 5 & 6)

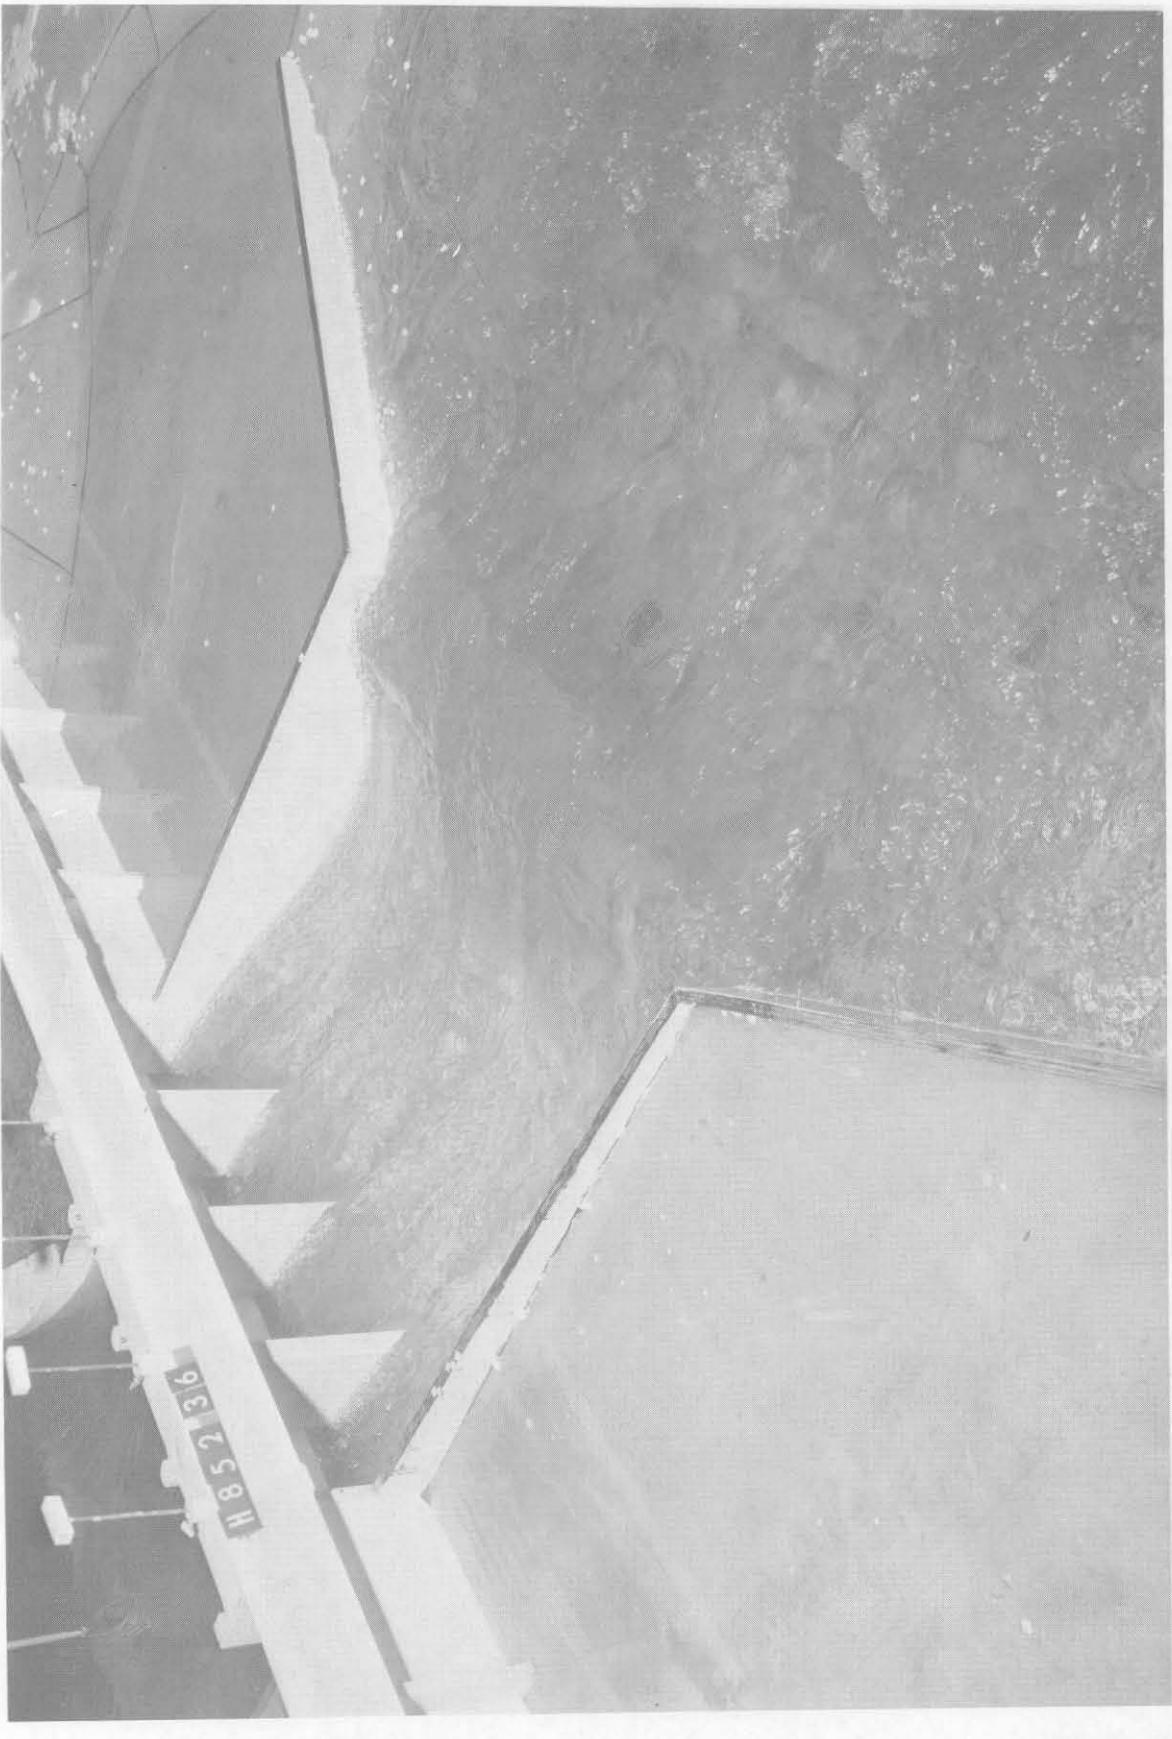
After calibration of the model, it was determined the hydraulic

jump would sweep out of the stilling basin or occur over the endsill under proper tailwater conditions (See Plates 9 & 10) as previously indicated by other models.

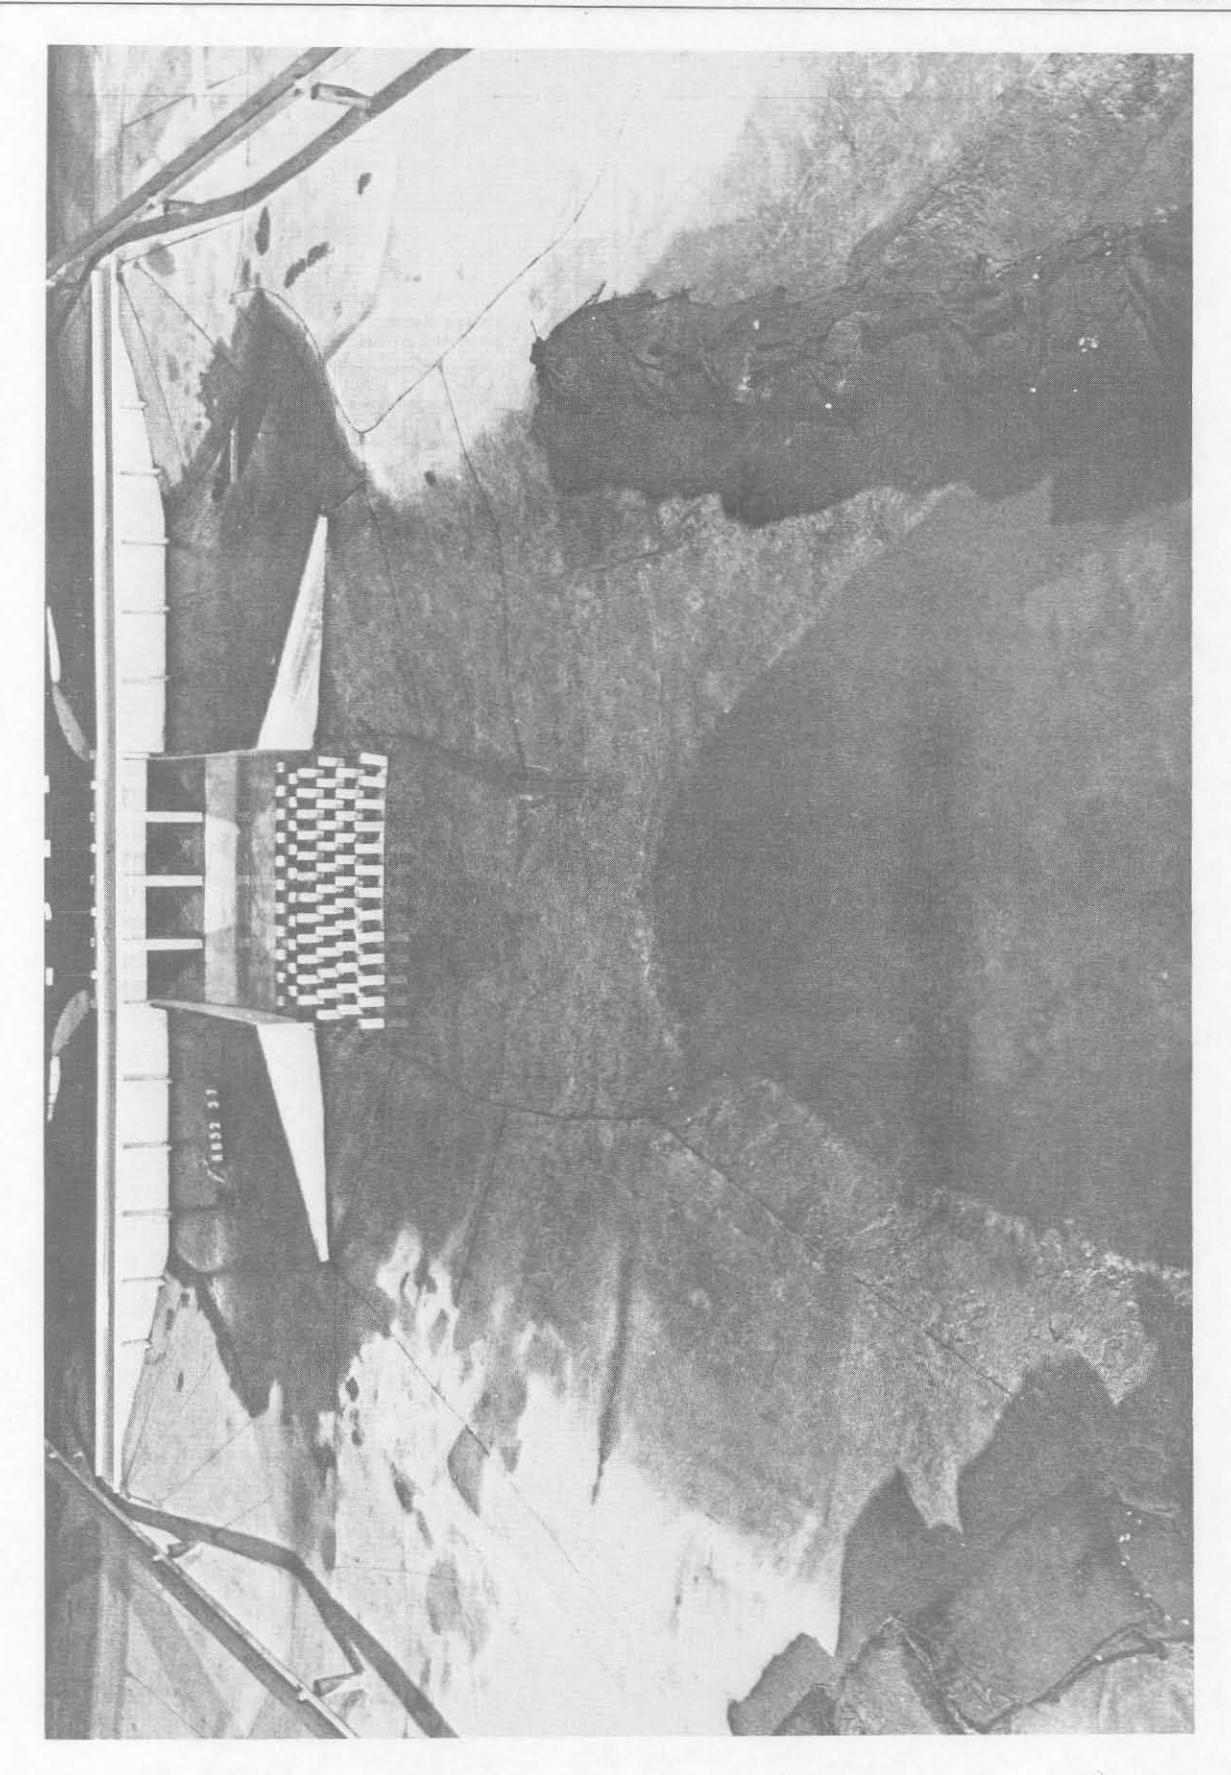
PLATE 11

Numerous structural and outlet channel modifications were evaluated. As discussed in the section model, different height baffles (See Plate 11) and fixed and floating baffle plates were evaluated in the structural model. No baffle configurations produced acceptable levels of energy dissipation without channel alterations.
