## SURGE EFFECTS FROM HURRICANE ELOISE

Walter W. Burdin

Navigation and Coastal Branch, Planning Division  
U. S. Army Engineer District, Mobile  
Mobile, Alabama

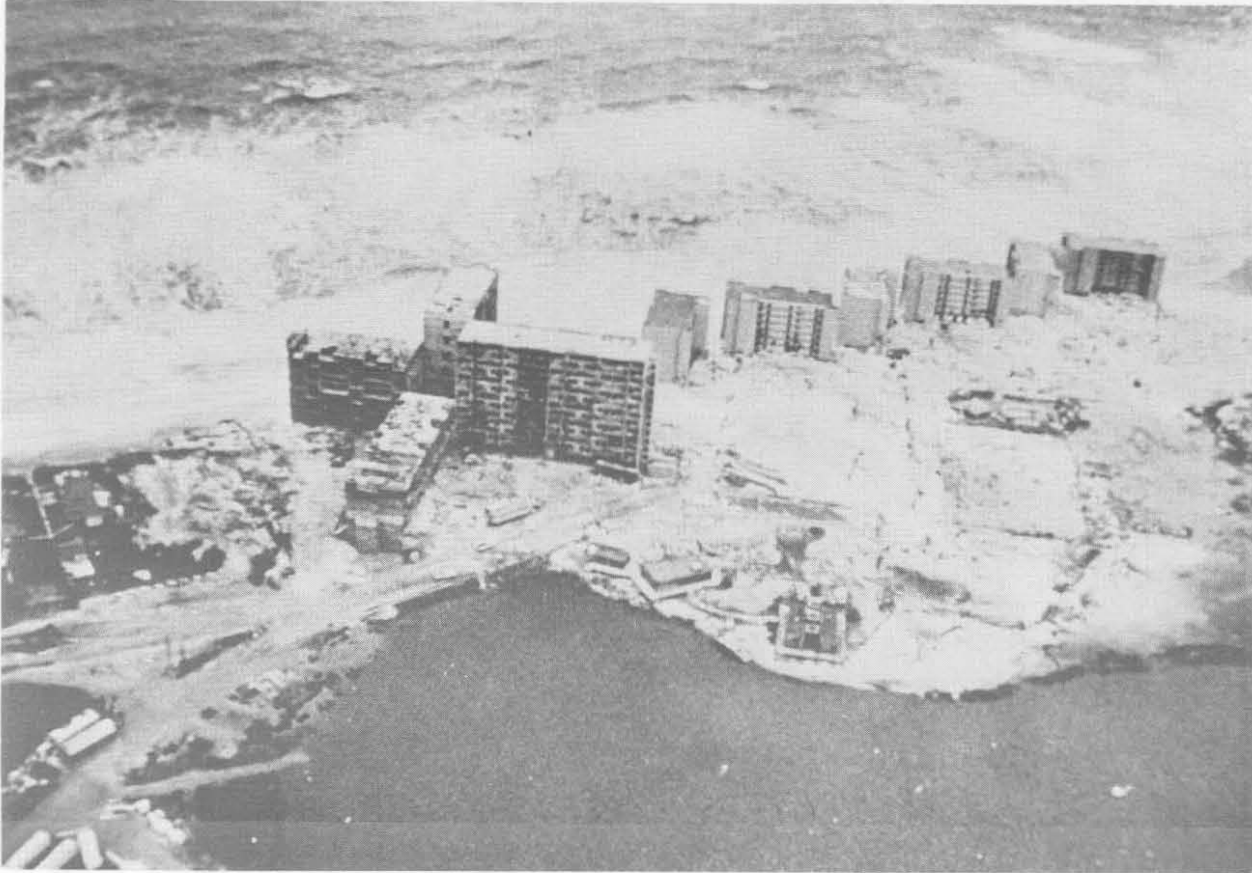
Figure 2 - Aerial Photo taken during Storm - just East of Philips Inlet

Figures 2 and 3 are aerial photographs taken by a press photographer from a U. S. Coast Guard aircraft which flew a reconnaissance over the area shortly after the eye passed inland. The photographs were taken at about 10:00 AM. Note that there is apparently no rain. Fortunately for the coastal region, there was relatively light rain during landfall.

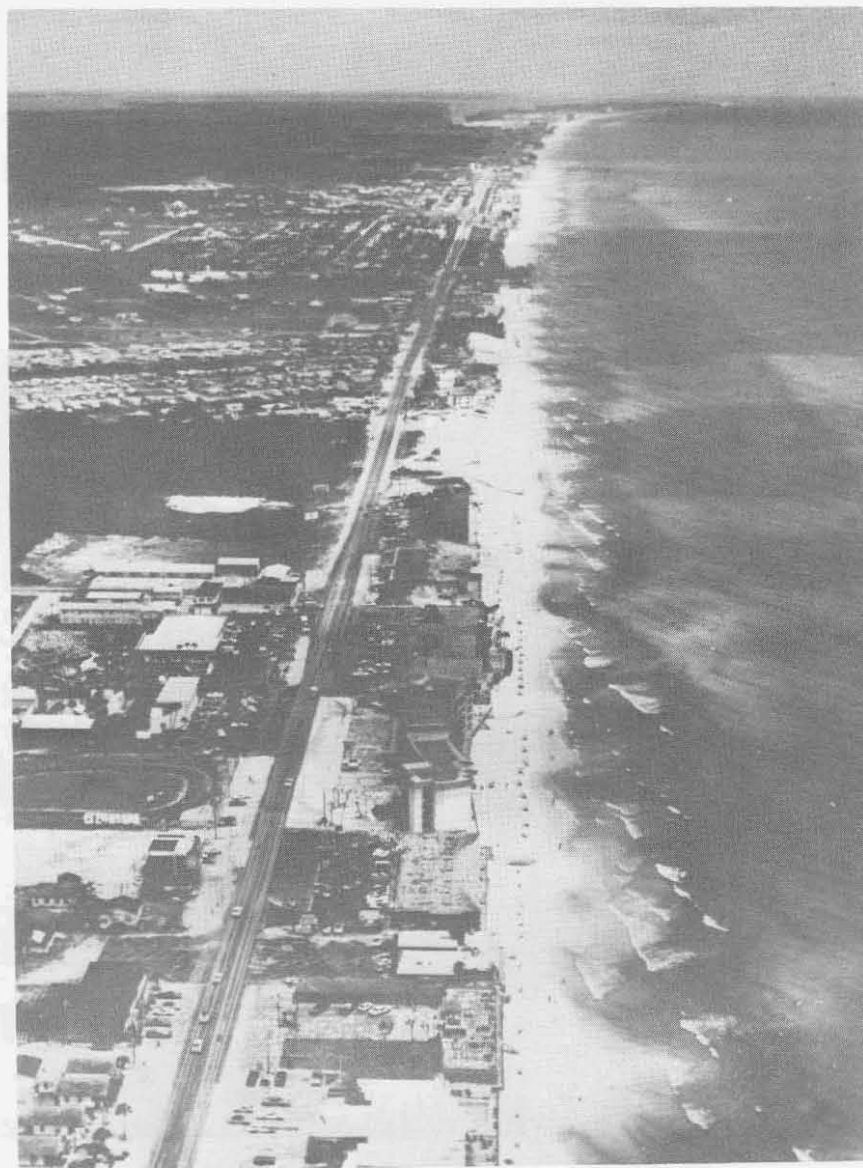
Figure 8 is an aerial photograph taken in June 1975 which shows development typical of the area. Destruction along the beach was extensive and in proportions never witnessed before in northwest Florida. Figures 9 through 14 show typical damages from Hurricane Eloise. The majority of the development along the beaches is atop or in front of the primary dune.

Figure 8 - Typical Development of Panama City Beaches - June 1975

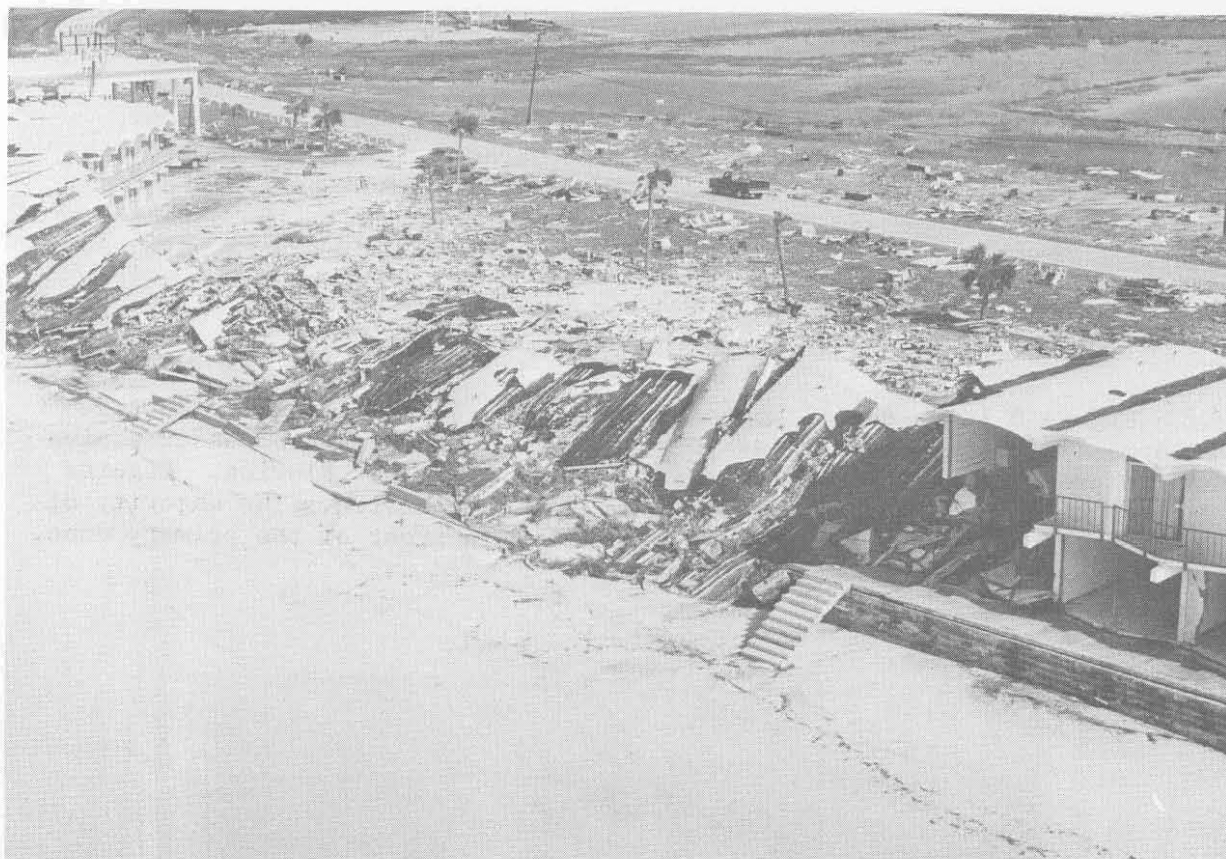
Figure 9 - Storm Damage to the Rountowner Motel

Protection from high tidal effects and/or storm surges is not provided except by bulkheads. Generally damages were relative to the proximity of the structure to the water's edge where the buildings closest to the water suffered the most extensive damages. Many of the bulkheads were reduced to rubble. Patios, pools, recreational equipment, structures, fill material and parking lots behind bulkheads were lost or severely damaged. The first floor of most motels and condominiums on the beach were gutted of furniture and fixtures. Load bearing walls remained intact but wall panels and glass were destroyed by the surge and wave action. Estimates of the total damages vary, but are on the order of \$80 million for the 18.5 mile reach.

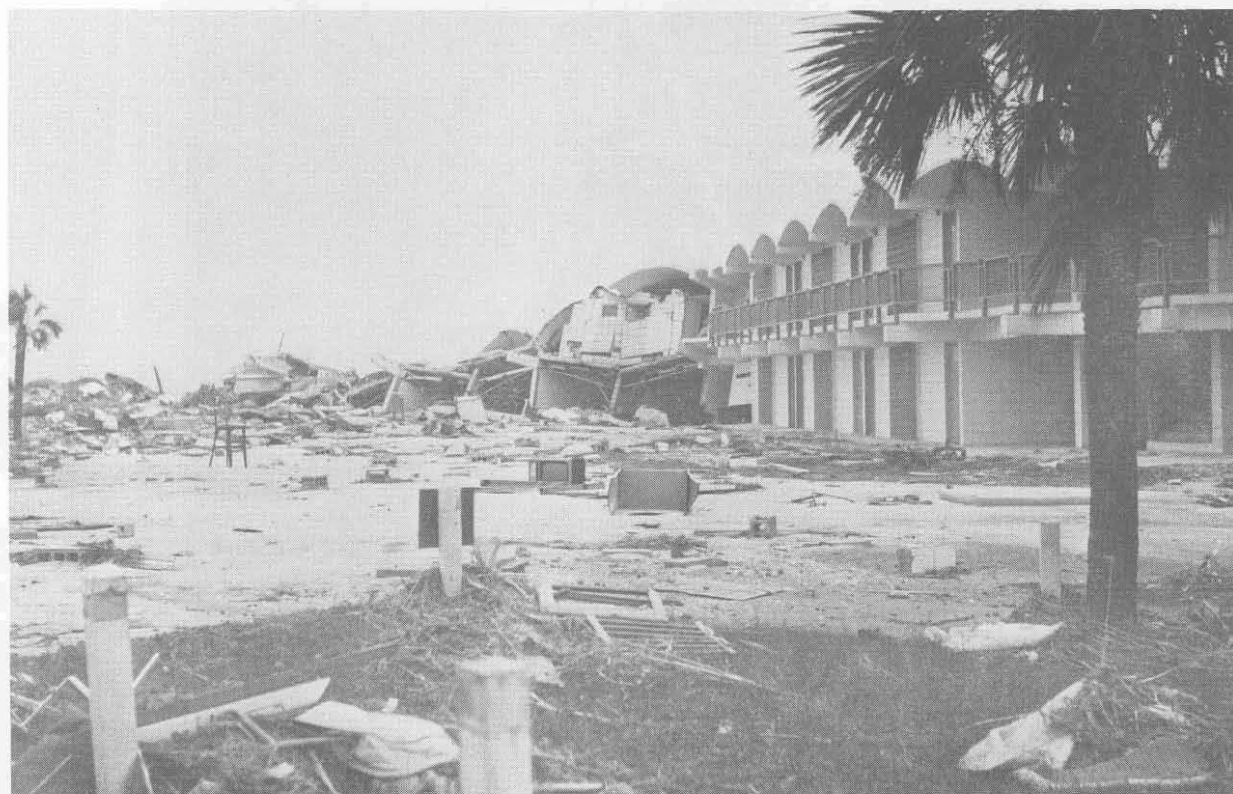
Figure 10 - Another View of the Rountowner

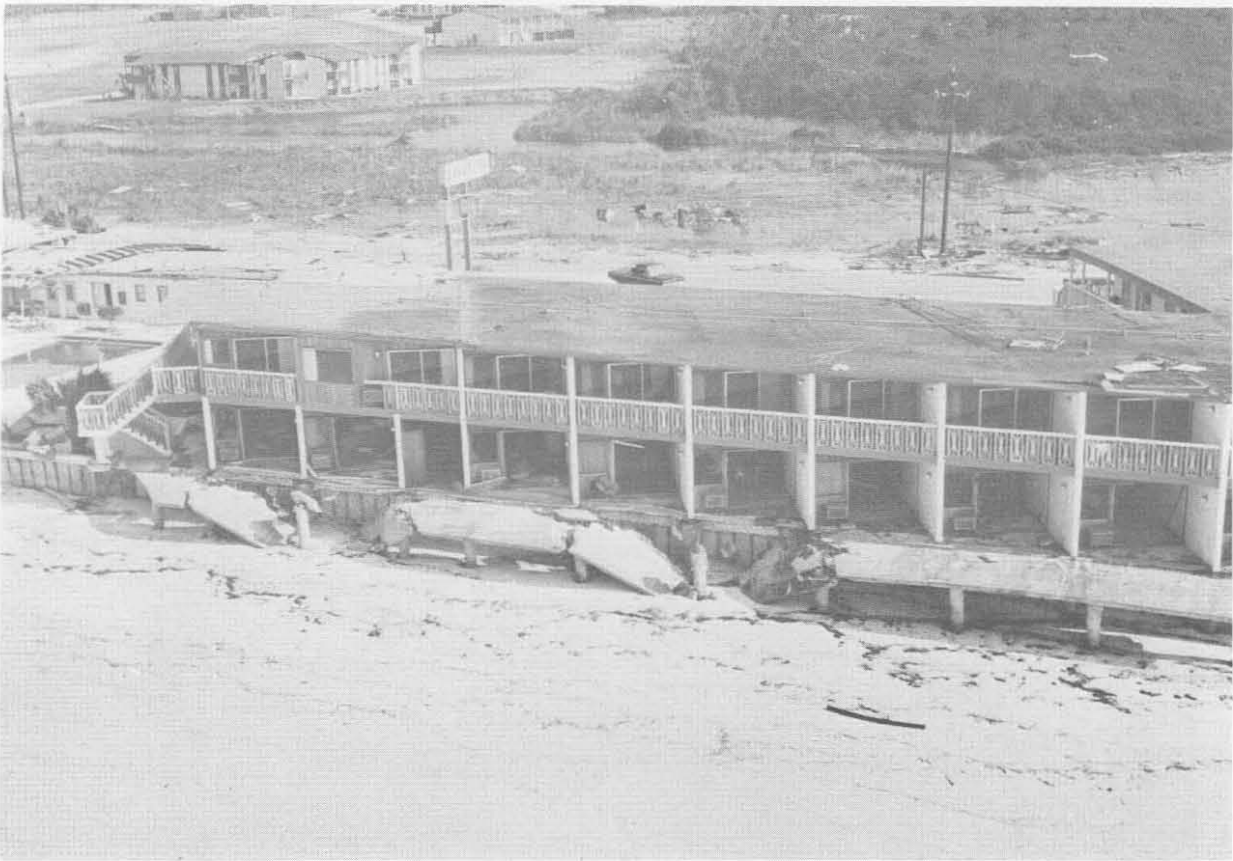
Figure 11 - Typical Damage from Hurricane Eloise

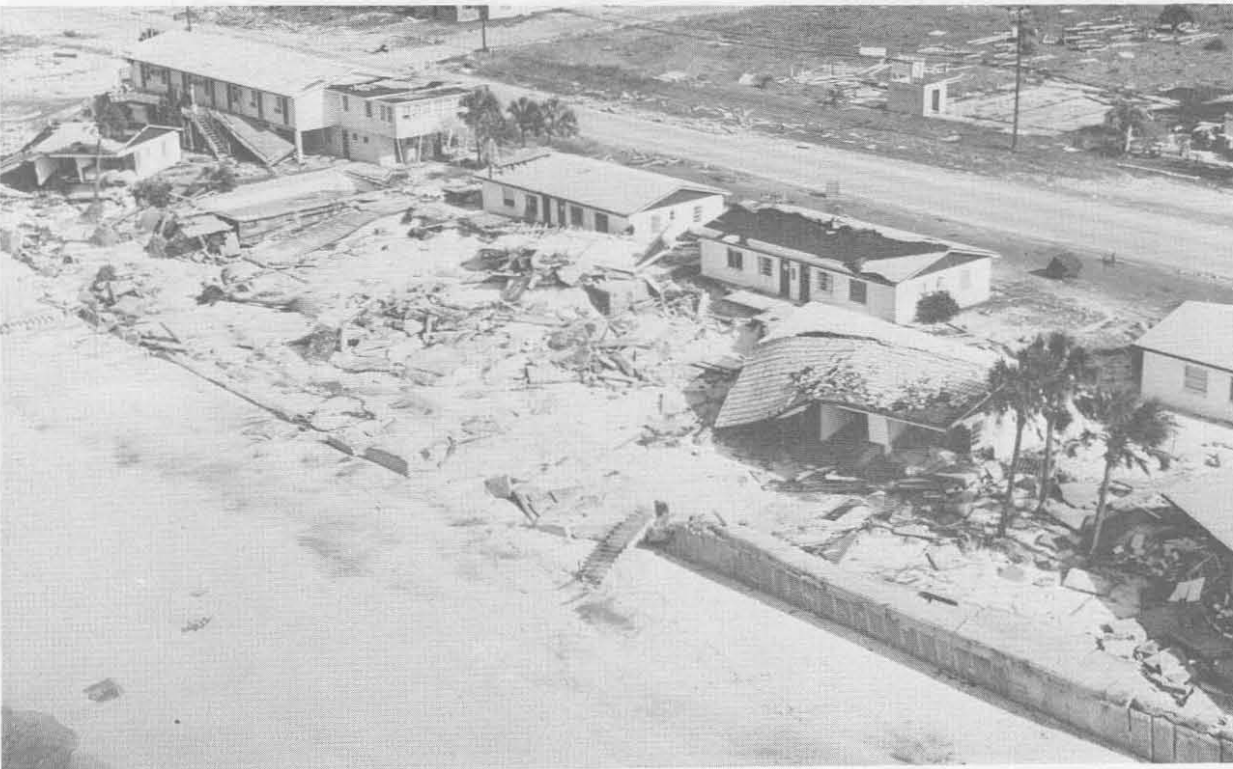
Figure 12 - Typical Damage from Hurricane Eloise

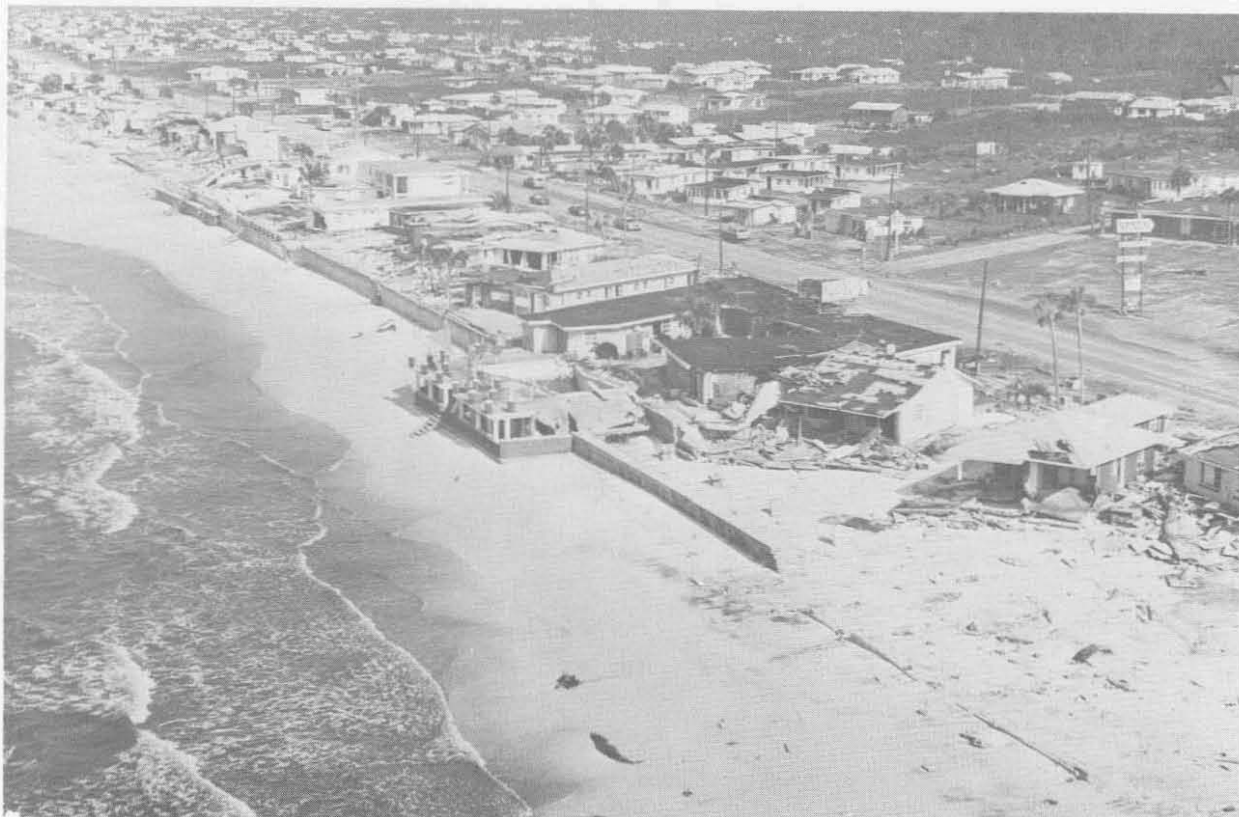
Figure 13 - Typical Damage from Hurricane Eloise

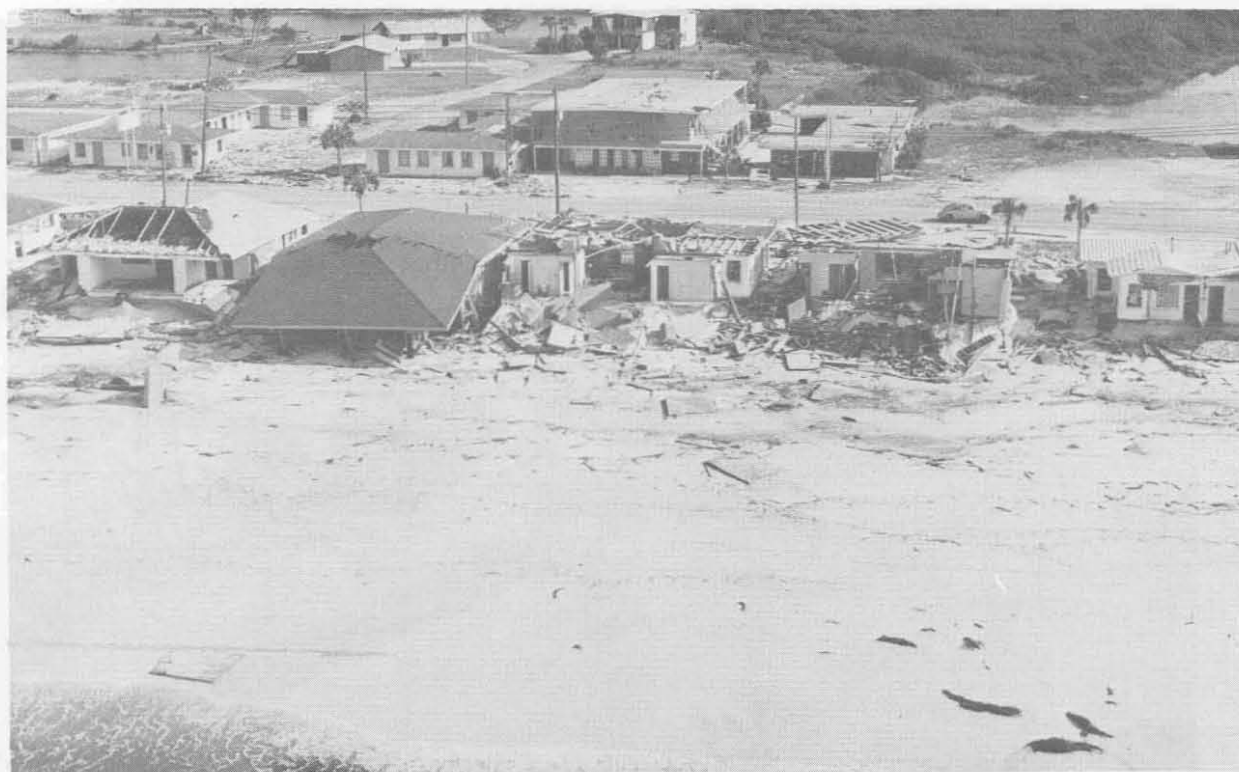
Figure 14 - Typical Damage from Hurricane Eloise

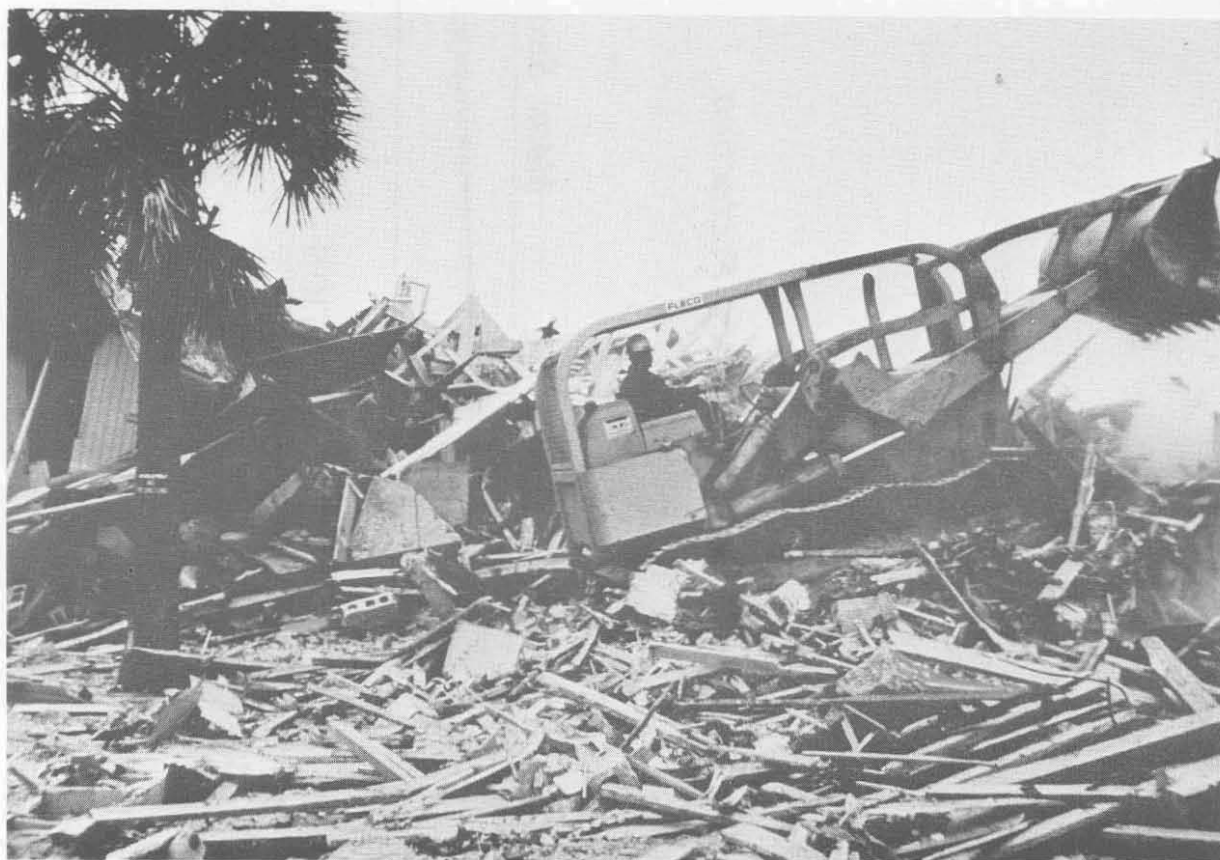
Figure 17 - Typical Demolition Scene

After the "Major Disaster" Declaration, the Mobile District advertised and awarded, in October 1975, three debris removal contracts which covered coastal Bay County from about Philips Inlet to St. Andrews State Park. (See Figure 15) These contracts were let for an estimated debris yardage at a specified unit cost and the three ultimately totalled \$76,457.00. Figure 16 is a typical "cleanup" scene. Three demolition contracts were awarded in January 1976 in the total amount of \$23,135.00 and a fourth in the amount of \$14,565.00 was awarded on March 12, 1976. Figure 17 shows a typical demolition job. All work has been completed.
