MODEL STUDIES OF STEELE BAYOU DRAINAGE STRUCTURE AND OUTLET CHANNEL AND REPAIRS TO OUTLET CHANNEL

Basil K. Arthur Hydraulic Engineer Corps of Engineers, Vicksburg District

PROCEEDINGS MISSISSIPPI WATER RESOURCES CONFERENCE 1985

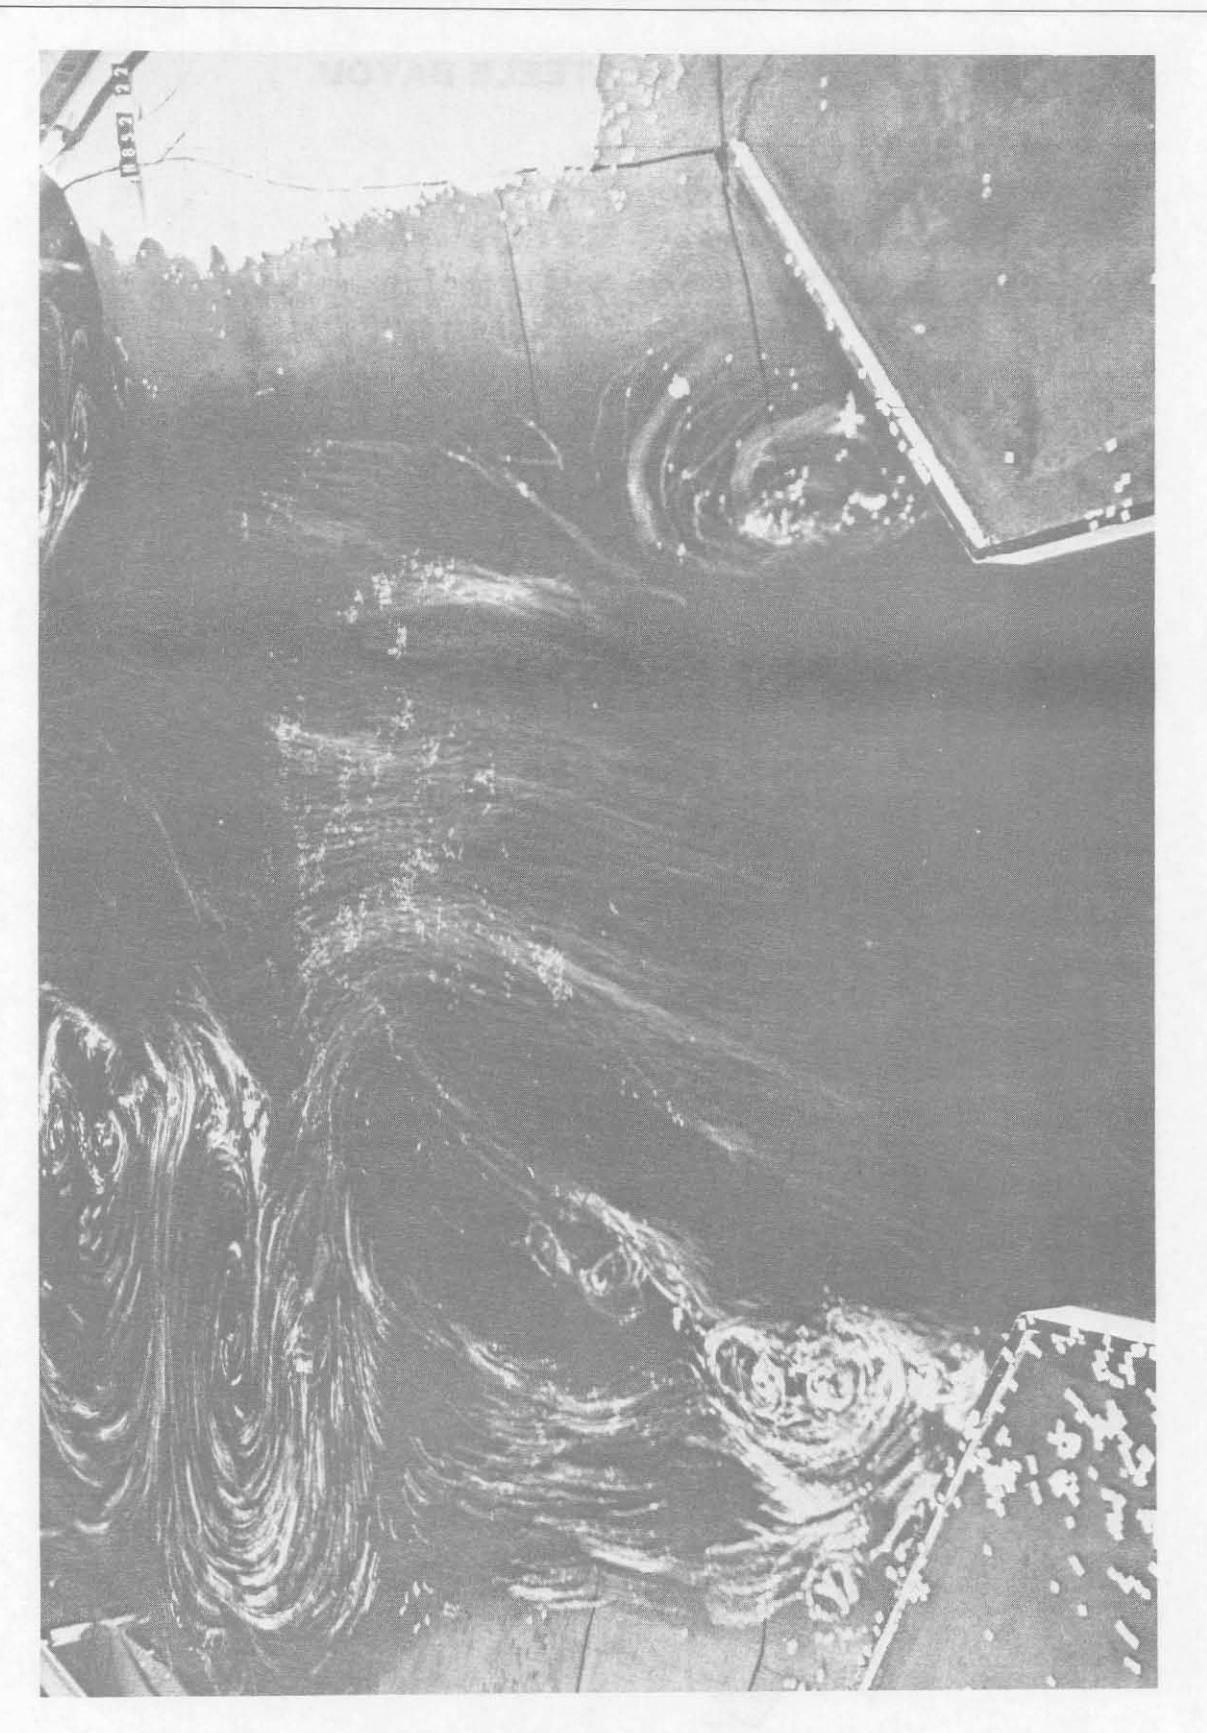
PLATE 5

The outlet channel continued to deteriorate and scallop until large scale eddies, standing waves, and vortices breached the access road during the spring runout of 1983. (See Plates 5 & 6)

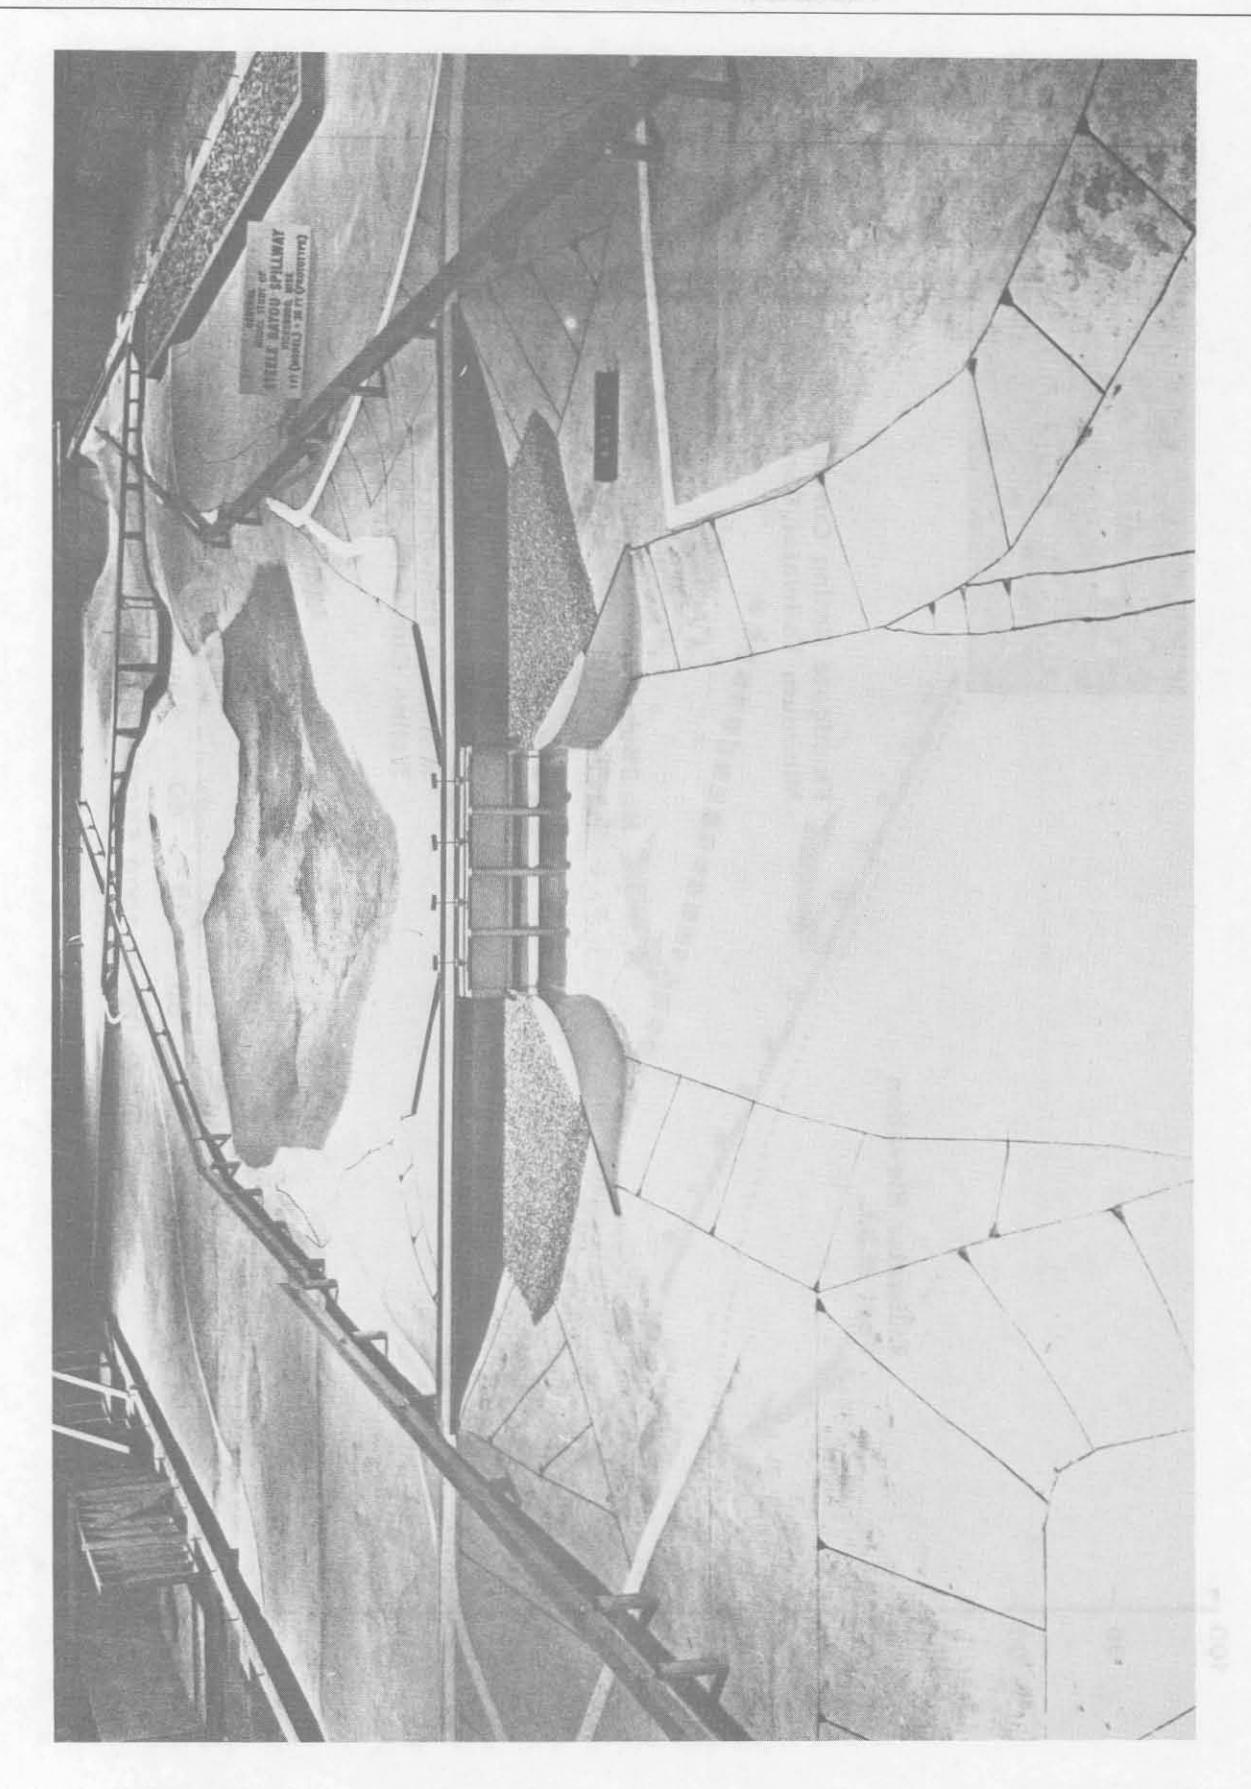
PLATE 8

A 1:36 scale model was constructed to reproduce adequate approach and exit areas, the entire structure, and riprap protection as existed in the outlet channel. The approach and overbank areas were molded of sand- cement mortar to sheet-metal templates. The structure was formed with sheet metal and plywood. (See Plate 8)

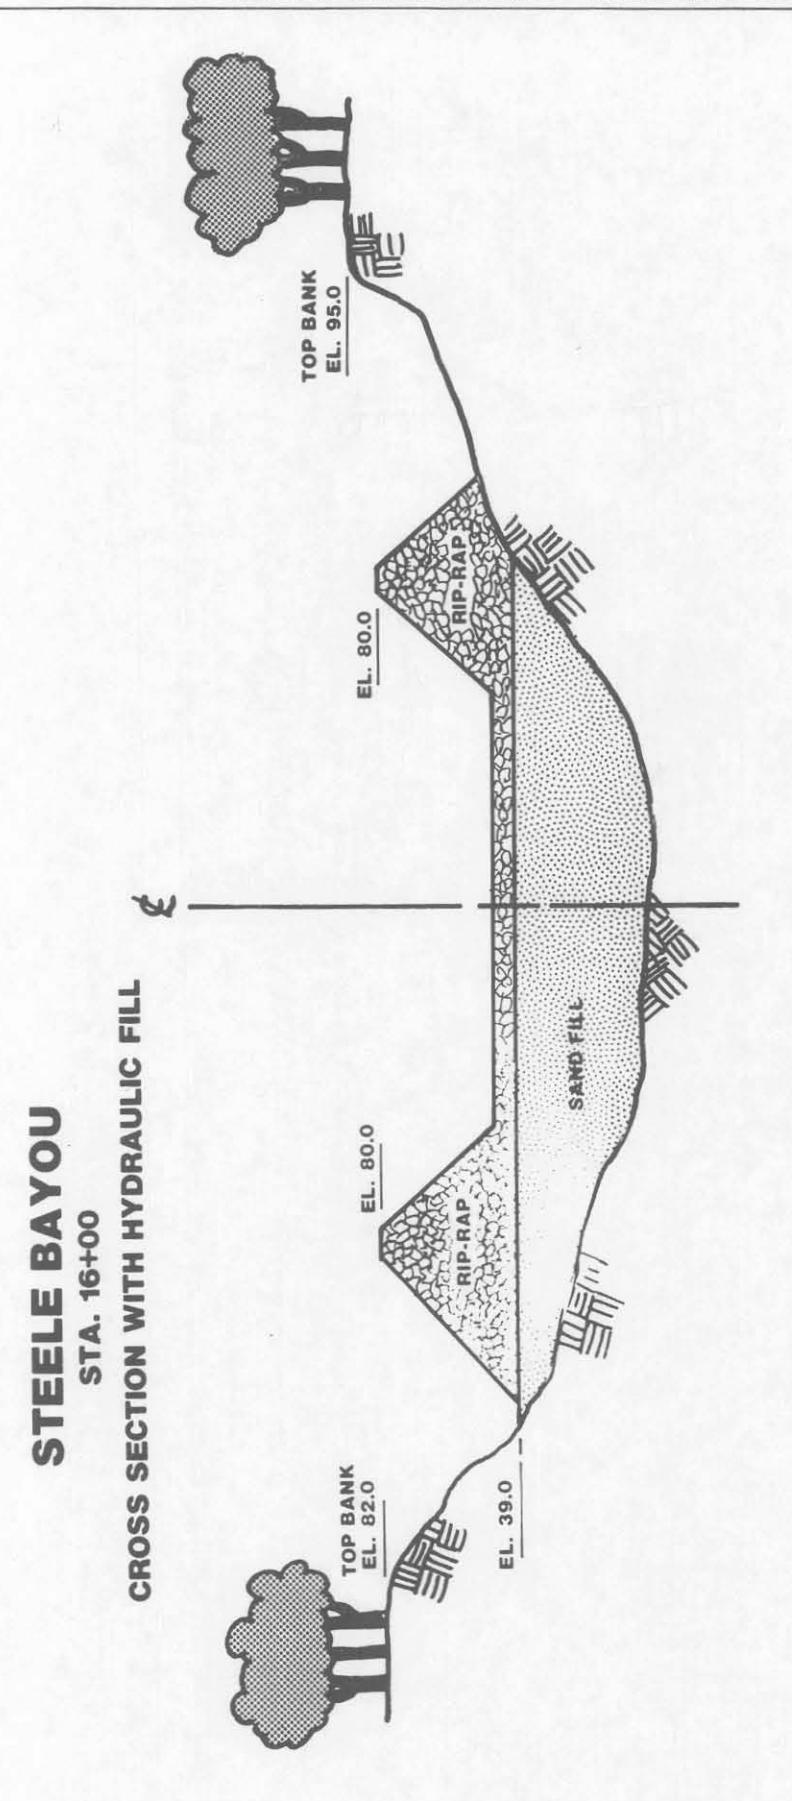
Longitudinal dikes enhanced the performance of the stilling basin and outlet channel better than any alternate configuration studied. Sandbags were removed from the model and the fixed mortar channel was replaced with a movable bed. The dikes were constructed of riprap with 1 on 3 side slopes and realigned parallel to each other. (See Plate 12) The existing channel bottom was capped with riprap.

Testing indicated good flow alignment with minimal eddies and return flows but large boils and turbulences still existed in the outlet channel. Recommendations were made to raise the channel bottom to reduce the turbulence. The channel bottom, previously at approximate elevation 35, was raised to elevation 45 and capped with riprap. (See Plate 13) Turbulence was tremendously decreased and minimal. No eddies were observed in the prismatically formed channel. This modification provided a solution to the majority of the hydraulic problems occurring at the structure and in the outlet channel.
